2010 the Deep Water Horizon encountered a blowout. The Blow Out Preventer should have prevented the following disaster but only partly worked. In this Event Map based on the US CSB animation we explain the chain of events.

Macondo well in the Gulf of Mexico

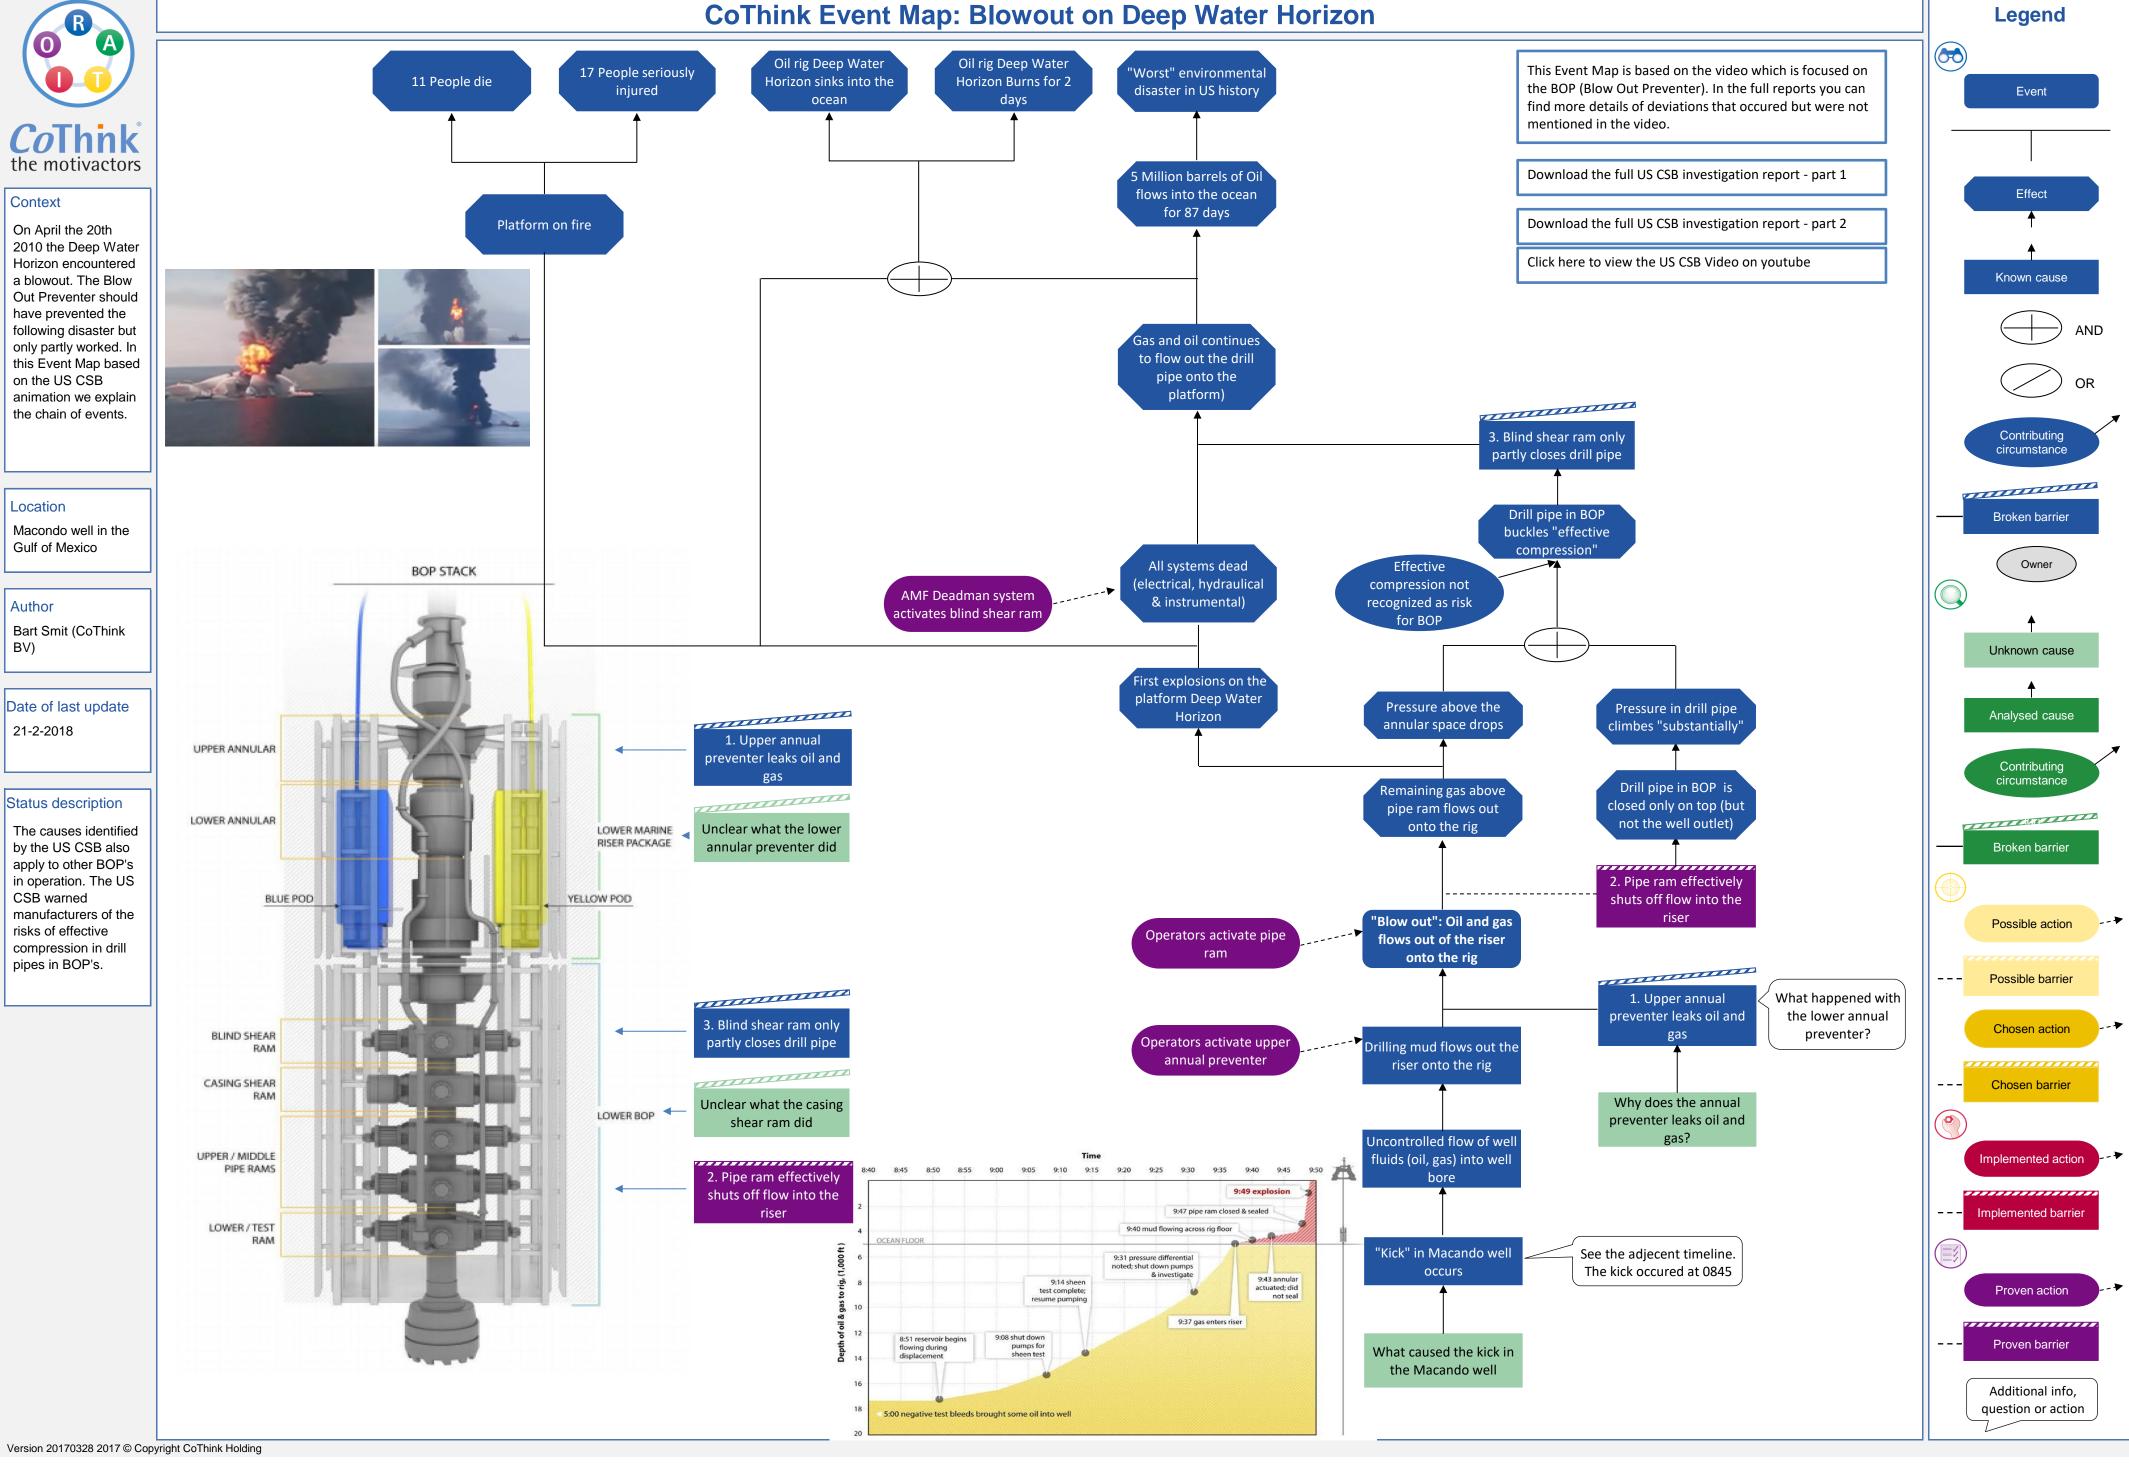
The causes identified by the US CSB also apply to other BOP's in operation. The US CSB warned manufacturers of the risks of effective compression in drill pipes in BOP's.
